Durability Studies and Characterization of the Matrix and Fibre-Cement Interface of Asbestos-Free Fibre-Cement Products

B. J. Pirie, F. P. Glasser

Abstract

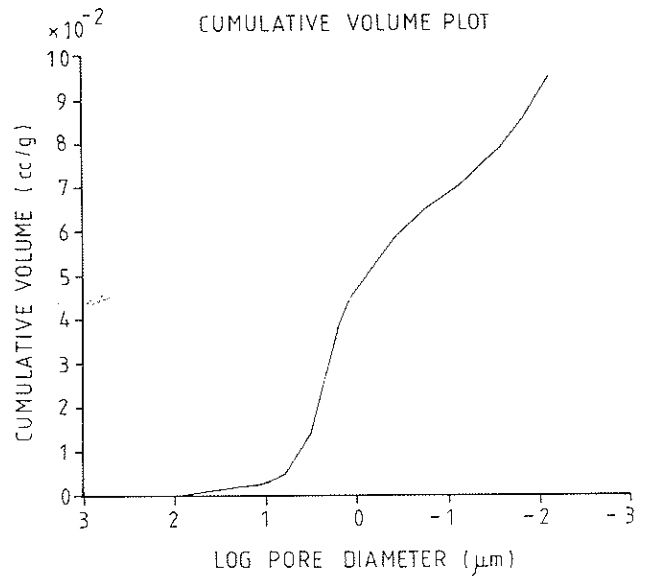
Fig. 14. Cumulative MIP scan of fresh product complementary to Fig. 12.

The cumulative volume plots for the non-aged and aged are shown in Figs 14 and 15 respectively, and indicate that there has been significant redistribution of pores. These aspects will be discussed in detail in the next section.

Superimposition of the graphs in Figs 14 and 15 show that the cumulative porosity in the smaller pore diameter region, 0.1–1.0 μm , is less after 3 years ageing. This represents the results of the continuing processes of hydration and carbonation and crack healing. However, in common with other cement materials, both composites, whether fresh or aged, are relatively porous.

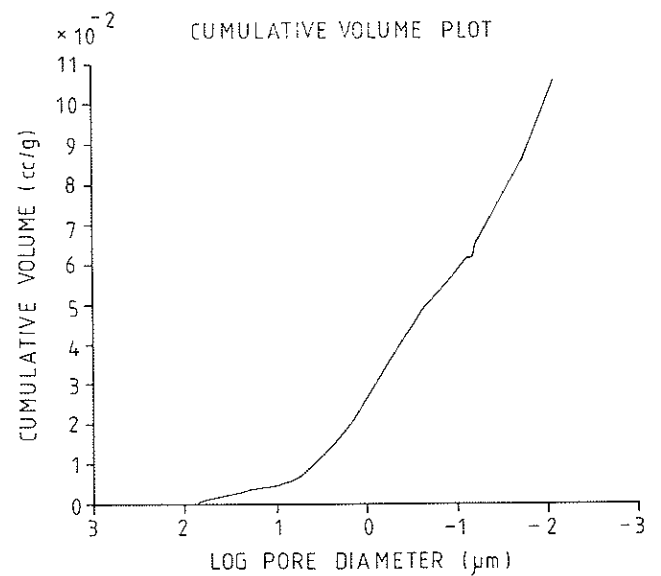
Fig. 15. Cumulative MIP scan of naturally-aged product complementary to Fig. 13.

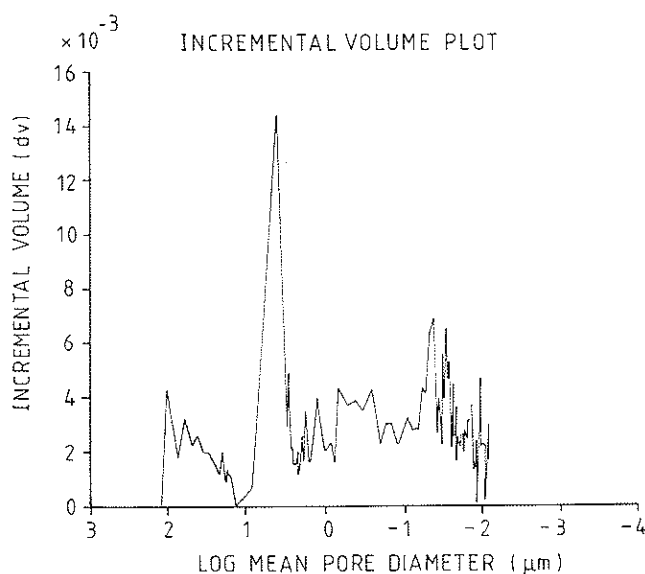
The results for non-aged and aged products are given in Figs 16 and 17. These show incremental

Fig. 17. Incremental MIP scan for autoclaved, naturally-weathered product complementary to Fig. 16.

volume plots (incremental volume plotted against pore diameter) for non-aged and aged materials respectively (note that the vertical scales are of different magnitude in each graph). The pore diameter decreases from left to right along the axis as the analysis sweeps from low to high pressures respectively. The plots are reasonably similar with the exception of the large peak at mean pore diameters $> 4 \mu\text{m}$, (Fig. 16).

The overall pore volume of the fresh material is greater than in the composites aged 4 years because, as ageing proceeds, many voids gradually fill with hydration and carbonation products. Thus pores with small diameters, $<1\ \mu\text{m}$, are unlikely to represent the same pores as in fresh material after 4 years exposure: owing to migration of material, their locus changes. The composites aged for 4 years displayed extensive microcracking by electron microscopy. These cracks varied in width but did normally exceed 0.5 μm . It may, therefore, be proposed that the incremental volume present for pore diameters $<0.5\ \mu\text{m}$, i.e. like the pore shown to the right of point X in Fig. 16, represent the cracking features identified in the aged samples. The two curves shown in the cumulative volume plots, Figures 16 and 17, are significantly similar, which suggests that some features of the original microstructure are preserved.
