# Durability Studies and Characterization of the Matrix and Fibre–Cement Interface of Asbestos-Free Fibre–Cement Products

B. J. Pirie, F. P. Glasser

## Abstract

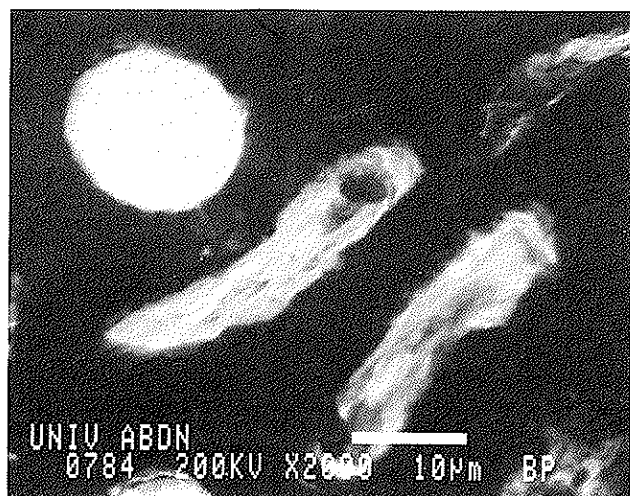
The atom milled cross-section using the STEM mode is shown in Fig. 1. Two types of fibre are evident in Fig. 1 and there is a greater tendency of the synthetic fibre to orientate normal to the section, relative to cellulose. The synthetic polymer fibres (PVA) are nearly round in cross-section, whereas the cellulosic fibres are irregular. The polymer material is preserved in the section, but owing to its transparency, does not reproduce well in black-and-white photographs of the relatively homogeneous PVA fibre; the internal structure of the cellulosic fibre is better revealed. Contact between fibres and matrix and between individual particles within the matrix is generally good. When a chemical image for silicon (Si) is obtained quartz particles stand out clearly and can be distinguished from limestone particles. One region of Si penetration into the fibre is noticeable. The complementary calcium (Ca) and sulphur (S) images obtained by analytical microscopy (not shown) show that considerable Ca has impregnated the walls of the cellulose fibres, and some penetration into the fibre itself has begun. The corresponding map for S shows that it is also one

Fig. 1. Atom milled cross section of non-aged cement board containing both synthetic fibre (round cross-section) and cellulose.

Using the scanning electron microscope a representative selection of micrographs (Figs 2 and 3) are given. These are complementary to the transmission micrograph given in Fig. 1.

It appears that the synthetic fibres generally lie at right angles to the section whilst the cellulose fibres display a lesser degree of orientation.

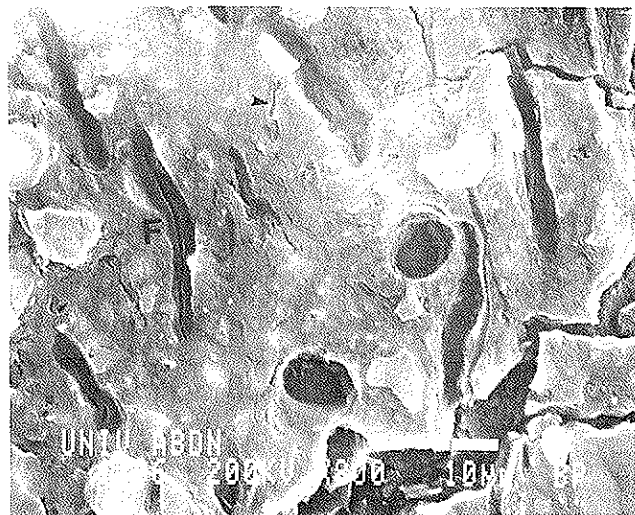
Scanning electron micrographs complementing the transmission micrographs of Fig. 4 are given in Figs 5 and 6. Figure 5 shows substantial areas which, by their slightly granular microstructure appear to be thoroughly carbonated. Two types of microcracking are evident: coarse cracks at lower right and finer cracks (arrowed) or elongated pores within the cement matrix. The microcracks generally tend to run normal to the surface of the section and pockets of porosity (S) are associated with their path. The crack along the cellulose fibre

Fig. 5. Scanning electron micrograph of naturally weathered, five-year-old material showing intensively carbonated matrix. F — cellulose fibres, and S — pocket of porosity.

(F) is tentatively ascribed either to shrinkage of the material or, less likely, to transfer of material from the outer margin of the fibre into its lumen. Synthetic fibres lying at right angles to the section are observed (P); their orientation is quite characteristically different from those of the cellulose fibres. An area with dense clustering, particularly of synthetic fibres, is seen in Fig. 6. There is a slight suggestion in this micrograph that clustering of fibres may determine crack direction but a wide range of fibre orientations are evident in this area. It is noted that where fibres lying parallel to the plane of section have been etched away by atom milling, the remaining imprint displays a degree of roughness on the walls. This may be the remains of fibre material, rather than an indication of porosity in the adjacent matrix, so it is concluded that bonding generally remains satisfactory. Clinker particles are prominent in the cement matrix but some of the smaller grains may be calcium carbonate (arrowed). The smooth triangular area (T) is likely to be a relic of a large clinker grain which has undergone hydration and carbonation, and is now merging with the background matrix. During the course of carbonation, some solution-reprecipitation reactions are likely to occur and it is not surprising that occasional cracks are favourably located with respect to filling. Crack rehealing occurs commonly and is an important process whereby the material can maintain its integrity during weathering.

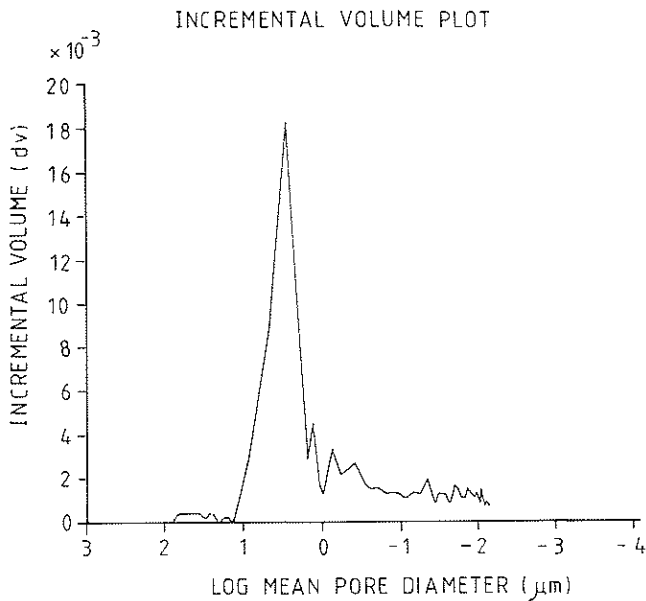
Tests were performed on non-aged and naturally aged products; the results are given in Figs 12–15. Figures 12 and 13 show incremental volume plots (increment volume plotted against pore diameter) for the non-aged and aged respectively.

**Fig. 12.** Incremental Mercury Intrusion Porosity (MIP) scan of fresh product.

material during weathering and carbonation, enhances the tendency towards a brittle failure mode. Considering the porosity of the product and its development with age, the significance of the graphs presented can be analyzed by examining the pore size distribution in different ranges. The large peak, around 3–5  $\mu\text{m}$  pore diameter, is an important characteristic of fresh material (Fig. 14). Whilst this range corresponds to the lumen diameter range of the cellulose fibre, this alone cannot account for the large intrinsic volume in this range because only the comparatively few exposed lumens of broken fibres are accessible to mercury. Moreover, the lumens of aged material are already partly filled. With the exception of the broken fibres, filling of any remaining void in the lumen must occur through the pores on the fibre walls. As these transverse pores are extremely fine, the effect, if any, is likely to add to the total porosity only within the finest pore sizes accessible to mercury. Thus the 3–5  $\mu\text{m}$  peak has to be ascribed to other origins and is believed to arise mainly from filling of microcracks and spaces in outer hydrate material.

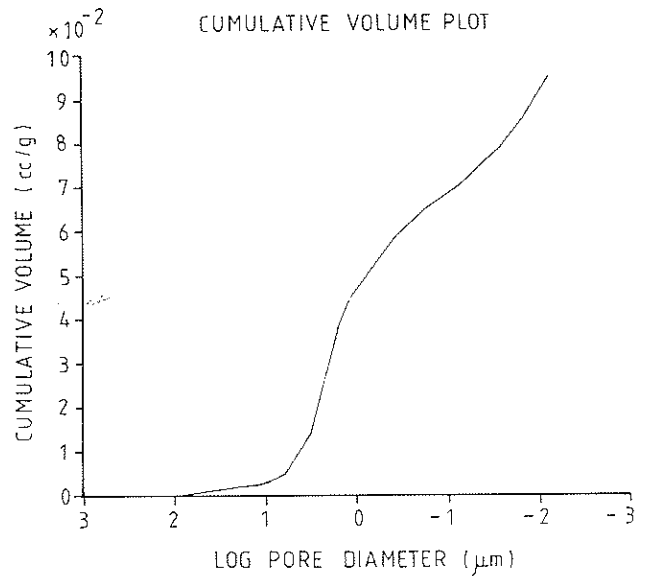
**Fig. 14.** Cumulative MIP scan of fresh product complementary to Fig. 12.

The cumulative volume plots for the non-aged and aged are shown in Figs 14 and 15 respectively, and indicate that there has been significant redistribution of pores. These aspects will be discussed in detail in the next section.

Superimposition of the graphs in Figs 14 and 15 show that the cumulative porosity in the smaller pore diameter region, 0.1–1.0  $\mu\text{m}$ , is less after 3 years ageing. This represents the results of the continuing processes of hydration and carbonation and crack healing. However, in common with other cement materials, both composites, whether fresh or aged, are relatively porous.

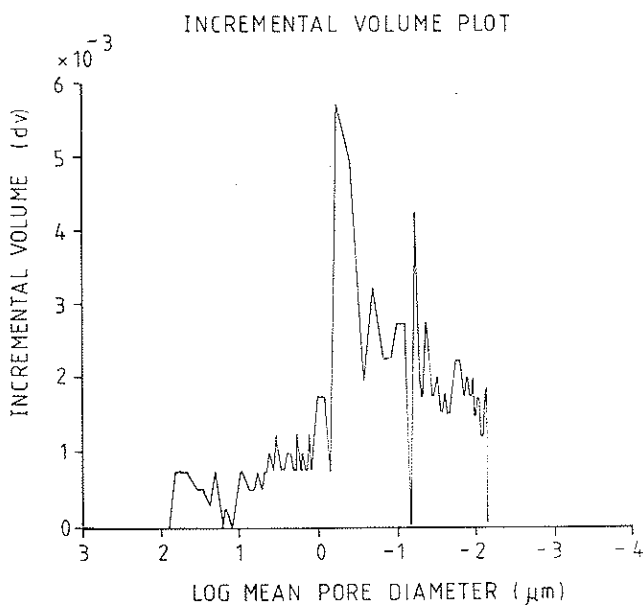
**Fig. 13.** Incremental Mercury Intrusion Porosity (MIP) scan of naturally-aged product.

After 3 years natural ageing the 3–5  $\mu\text{m}$  peak has disappeared (Fig. 13), the incremental volume having decreased from a maximum of  $18 \times 10^{-3}$  to a background level of  $1 \times 10^{-3} \text{ cm}^3 \text{ g}^{-1}$ . This suggests that these larger voids have become filled, or at least blocked, by hydration and carbonation products in the course of ageing; it is also known that some lumen filling has occurred. The incremental volume in the 0.1–1.0  $\mu\text{m}$  range has risen slightly over three years, and can be related to a decrease in the mean diameter of larger pores as a result of partial filling and pore entry blocking. These factors, together with continued hydration and carbonation, work cooperatively with the result that the peak in pore size distribution is shifted into the  $\sim 0.5 \mu\text{m}$  diameter pore regime.

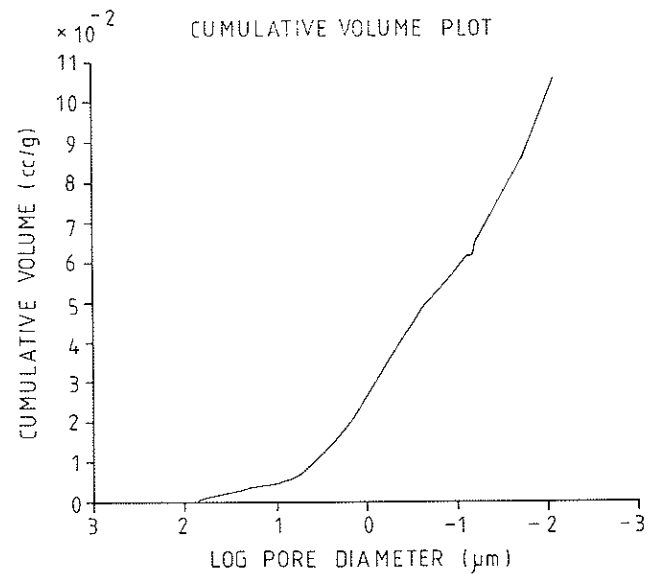
**Fig. 15.** Cumulative MIP scan of naturally-aged product complementary to Fig. 13.

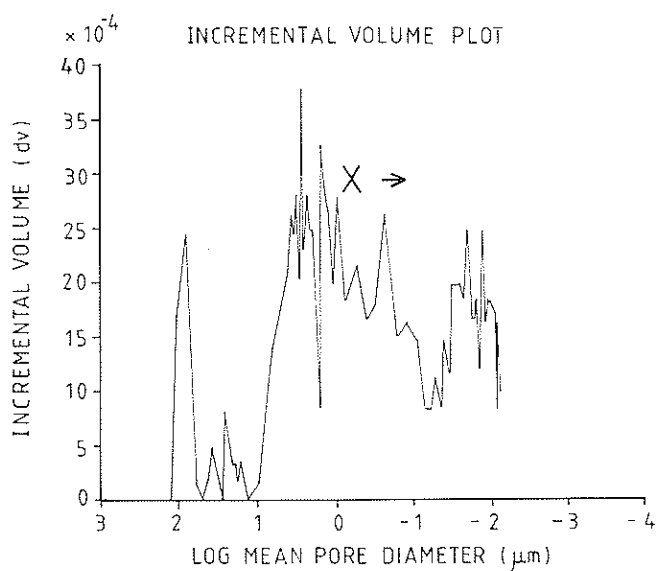
The results for non-aged and aged products are given in Figs 16 and 17. These show incremental

Fig. 16. Incremental MIP scan for autoclaved fresh product.

volume plots (incremental volume plotted against pore diameter) for non-aged and aged materials respectively (note that the vertical scales are of different magnitude in each graph). The pore diameter decreases from left to right along the axis as the analysis sweeps from low to high pressures respectively. The plots are reasonably similar with the exception of the large peak at mean pore diameters  $> 4 \mu\text{m}$ , (Fig. 16).

The overall pore volume of the fresh material is greater than in the composites aged 4 years because, as ageing proceeds, many voids gradually fill with hydration and carbonation products. Thus pores with small diameters,  $<1\ \mu\text{m}$ , are unlikely to represent the same pores as in fresh material after 4 years exposure: owing to migration of material, their locus changes. The composites aged for 4 years displayed extensive microcracking by electron microscopy. These cracks varied in width but did normally exceed 0.5  $\mu\text{m}$ . It may, therefore, be proposed that the incremental volume present for pore diameters  $<0.5\ \mu\text{m}$ , i.e. like the pore shown to the right of point X in Fig. 16, represent the cracking features identified in the aged samples. The two curves shown in the cumulative volume plots, Figures 16 and 17, are significantly similar, which suggests that some features of the original microstructure are preserved.
