# Fibre-matrix interface effects in asbestos-cement composites

The microstructure and failure mode of the fibre-matrix interfacial region in asbestos-cement composites have been investigated, primarily by scanning electron microscopy. Processes of bonding and debonding are shown to be complex, involving a variety of mechanisms. Mutual interlocking has been observed between asbestos fibrils and calcium silicate hydrate needles, whereas fibre pull-out occurs primarily through matrix failure adjacent to the interface, together with some interfibre separation.

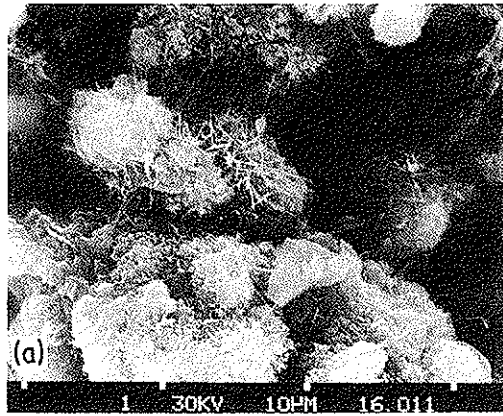
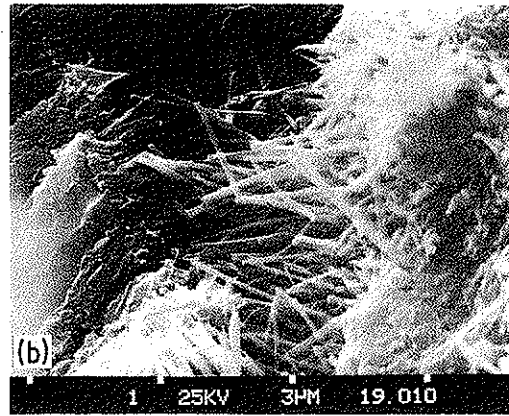
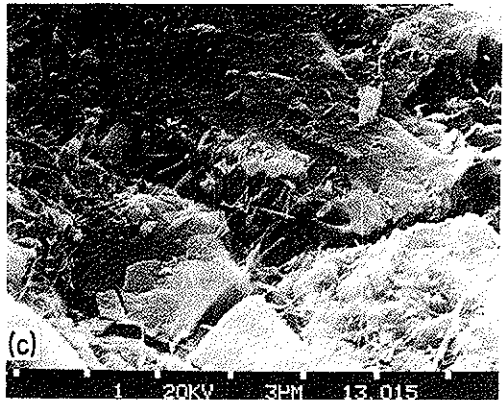
Figure 1 Calcium silicate hydrate of the needle morphology which interlocks and binds cement particles together, (a) and (b), as well as microcracks formed during curing (c).

The hardening of Portland cement is primarily due to the hydration of the constituent di- and tri-calcium silicates. A wide variety of corresponding microstructural forms have been identified over the years, and variously described as: needles, fibres, cigar-shaped sheets, plates, crumpled sheets or foils, tabulated structures, thin sheets, spicules, spherulitic particles and rosettes [7]. Indeed, very recently the origins of, and influences controlling, such structures have been the subject of enthusiastic debate [8, 9] beyond the scope of this paper. However, prime amongst the structural forms of the hydrates is that of needles or tubular fibres (Fig. 1), which are widely considered to play a dominant role in the strength development of hydrating cement. Thus, these needles can be seen to interlock and bond together adjacent cement particles (Figs. 1a and b), providing the basis for the mechanical strength of the material. They can also grow across voids in the structure, resulting in an overall decrease in porosity, as well as act to inhibit crack initiation at such voids; furthermore, they can bridge microcracks formed during curing, Fig. 1c, again leading to local strength improvements.

asbestos fibrils, Fig. 2c, will interlock with the cement hydrate needles which can be seen, Fig. 1b, to be of similar dimensions. This interlocking, shown in Fig. 3, is obviously beneficial to the strength of the composite, and would appear to represent an interesting new variation to the more conventional models of load transfer in fibre reinforcement. Even in the case of large fibre bundles, there is reason to believe that such an interlocking mechanism may contribute to the strength of the bond between a fibre bundle and the matrix. Thus Fig. 4 shows evidence of the presence of fine asbestos fibres, of dimensions again similar to the needle-like cement hydrate form, on regions of the all-important surface of the bulk fibre bundle.

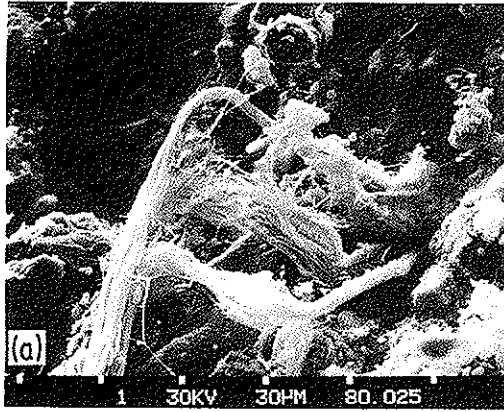
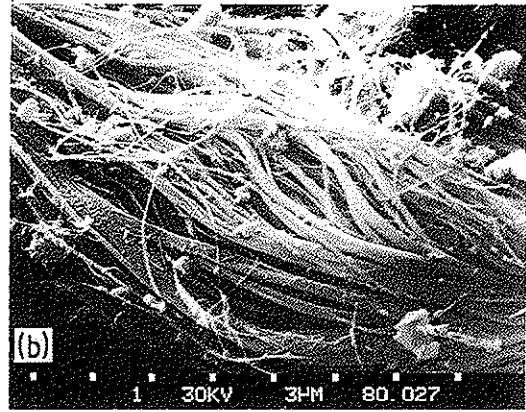
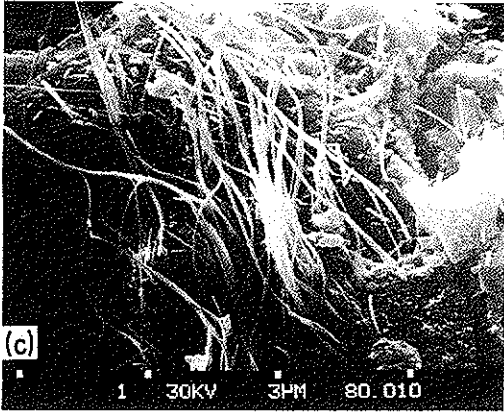
Figure 2 Progressive opening of fibre bundles during the fiberizing treatment.

Turning attention to the asbestos fibres, an investigation of the microstructural implications of one of the production line processing treatments, known as "fiberizing", has shown that this involves the progressive opening of asbestos fibre bundles, Fig. 2. In a cement matrix, the fine

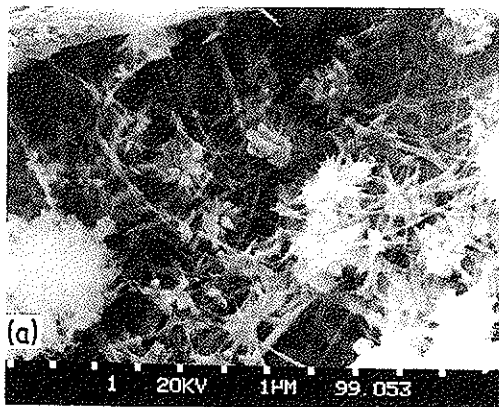
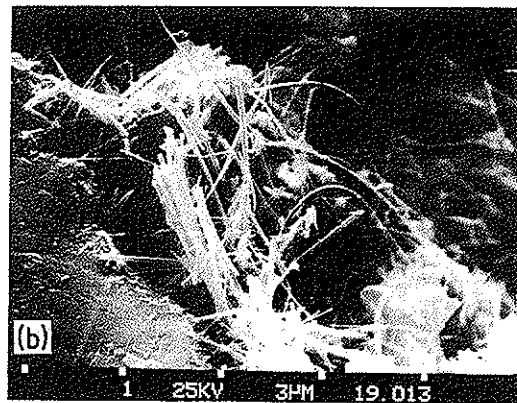
Figure 3 Interlocking of fine asbestos fibres with calcium silicate hydrate needles.

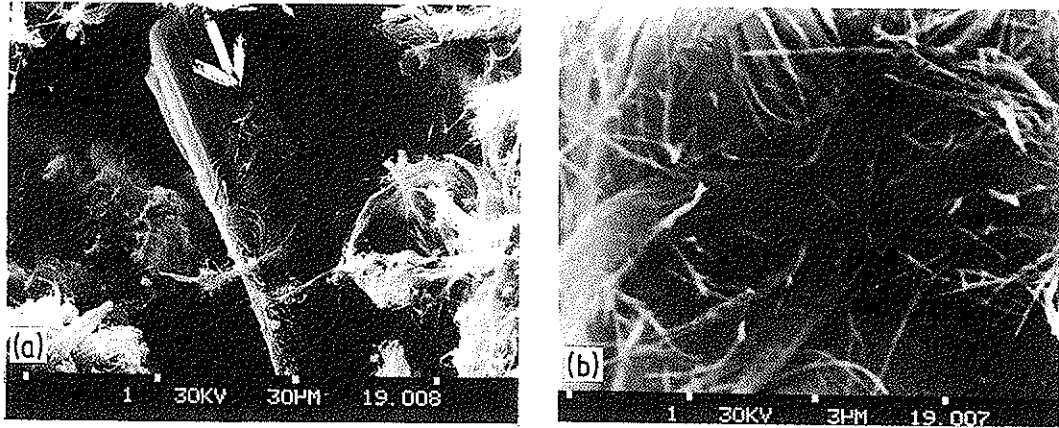
Figure 4 Fine fibrils found on the surface of large fibre bundles; (b) is the region arrowed in (a) at higher magnification.

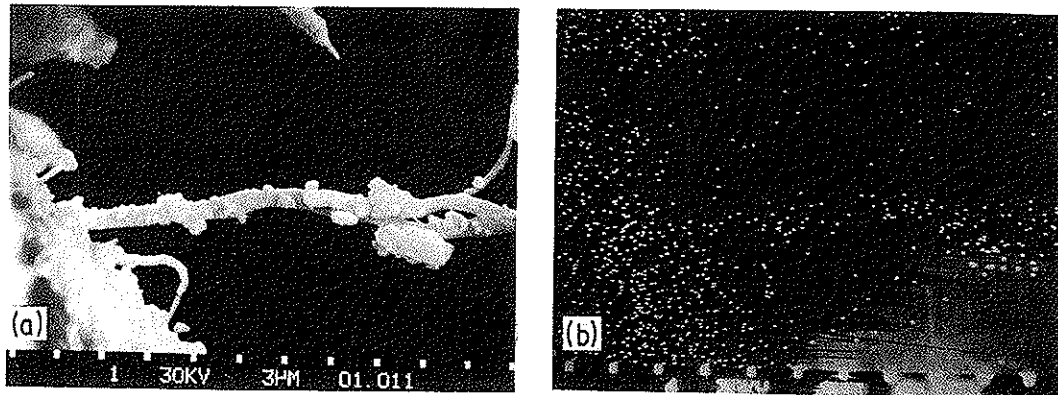
Figure 5 (a) Typical fibre bundle pulled out of a cement matrix, still covered with a layer of cement. (b) A CaK $\alpha$  elemental distribution map of this fibre bundle confirms the presence of calcium, which could only have come from the cement left adhering to the bundle.

Using X-ray analysis on a typical fibre bundle which has been pulled out of the cement matrix (Fig. 5a), there are obvious traces of small cement particles adhering to the fibre bundle. Since the chrysotile asbestos fibres used do not contain calcium, from a calcium elemental distribution map of the fibre bundle, Fig. 5b, it is clear that a thin film of cement is adhering to the fibre bundle, as has previously been reported by Majumdar [2]. In other words, failure has taken place in the cement *adjacent* to the interface, as distinct from

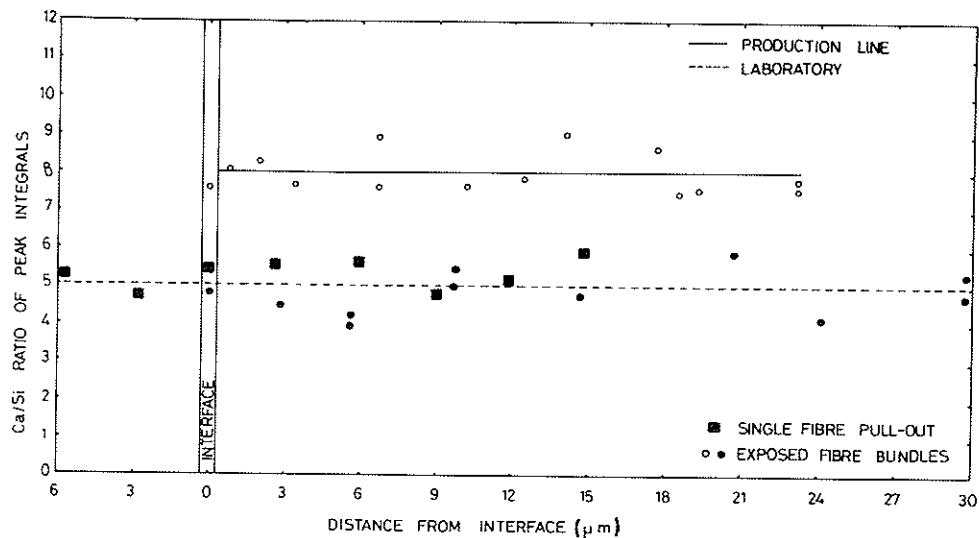
Figure 6 Corrected Ca/Si ratios of the fibre-cement matrix interfacial region, indicating no  $\text{Ca}(\text{OH})_2$  enrichment.

If debonding initiates at a weak calcium hydroxide-enriched zone within the matrix and away from the interface, a higher value would be expected for the calcium/silicon ratio on the surface of a pulled-out fibre bundle, when compared with that obtained from the bulk. However, line scan X-ray analysis carried out at, and away from, the interface of exposed fibre bundles, suitably corrected for the silicon content of the asbestos fibres, indicates that there is no such calcium hydroxide-enriched zone, Fig. 6. This result is consistent for both laboratory and pro-

It could also be argued that if some weak, calcium hydroxide-rich zone did occur, calcium hydroxide crystals could dislodge from the cement adhering to the fibre bundle during pull-out, leaving behind the majority of the calcium hydroxide in the residual trough. For this reason line scan analyses were also performed in, and at various distances from, a cement trough out of which a single fibre bundle had been extracted. Again (Fig. 6) no zone enriched in calcium hydroxide is evident.

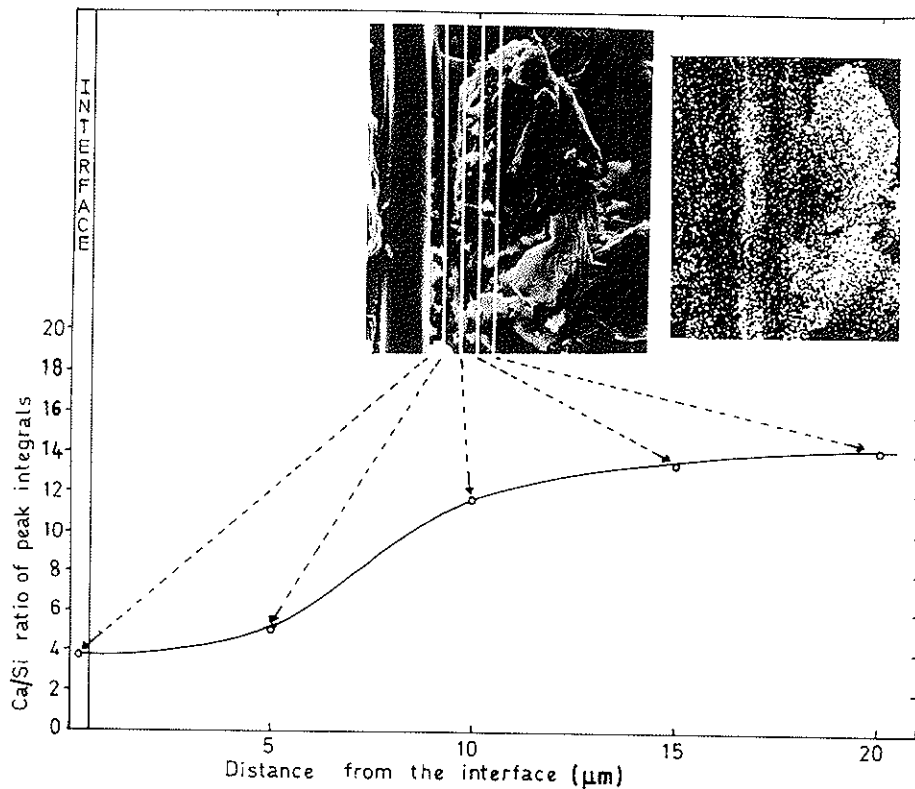
Figure 7 Local increases in the Ca/Si ratio, as determined by line scan analyses away from the interface, due to the presence of a calcium hydroxide crystal, identified by its high calcium content (see insets at magnification  $\times 430$ ).

calcium/silicon ratio by a factor of 2 above the bulk value were recorded, Fig. 7. Elemental distribution mapping, Fig. 7, confirmed the presence of individual calcium hydroxide crystals in such areas. Such irregularly occurring calcium

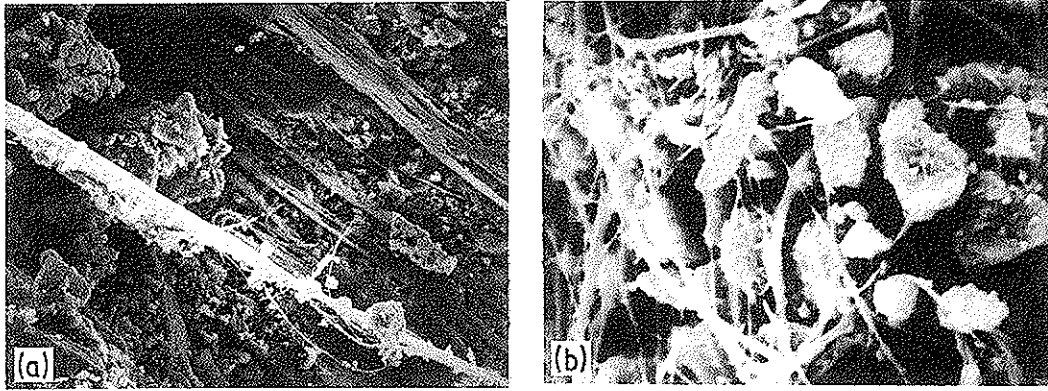
Figure 8 (a) Chrysotile fibrils remaining in a cement trough after pull-out. At higher magnification (b) the complex interaction between these fibrils and the cement particles is clearly illustrated.

An example of this is shown in Fig. 8a. A higher magnification fractograph of a typical trough, Fig. 8b, illustrates the complex manner in which the fibrils interact with cement particles, as has been discussed previously. Fig. 9a shows how a sheath of fibrils has separated from the extracted chrysotile fibre bundle. This separation of the sheath from the main core could clearly be seen when observing (with the aid of an optical microscope) the section of the fibre bundle outside the pellet caps during pull-out: the sheath separates from the fibre bundle at a distance outside the cement cylinder, Fig. 9b.

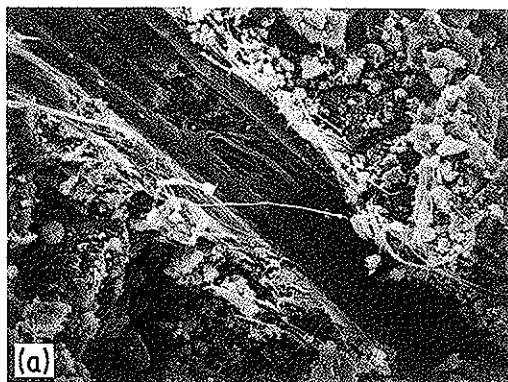
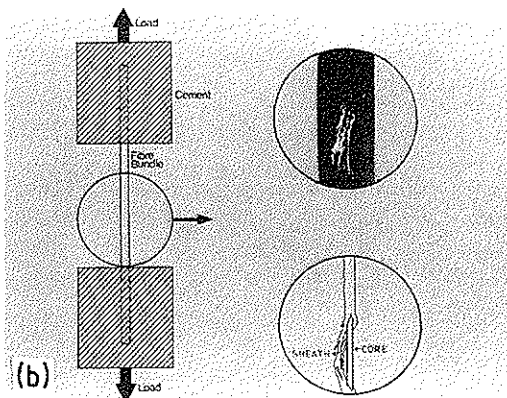
Figure 9 (a) A full sheath of chrysotile fibres remaining in a cement trough, after the bulk of the particular fibre bundle has been pulled out. (b) The mechanism of this separation observed with optical microscopy on a single fibre bundle pull-out specimen, illustrating the sheath shedding from the inner core as load is applied.
