The microstructure and ageing of cellulose fibre reinforced cement composites cured in a normal environment

A. Bentur* and S. A. S. Akerst†

Synopsis The correlations between microstructural changes after ageing and the mechanical performance of cellulose fibre reinforced cement composites were studied. Ageing conditions which promote carbonation (natural ageing and accelerated ageing in a CO₂ rich environment) result in densening of the matrix around the fibres and the petrification of the fibres, leading to an increase in strength and E-modulus. Accelerated ageing in a normal environment leads to densening of the matrix without fibre petrification, resulting in a reduction in strength. Both ageing environments led to a marked reduction in toughness. The processes leading to petrification and matrix densening are discussed with a view of explaining the changes in mechanical properties after ageing.

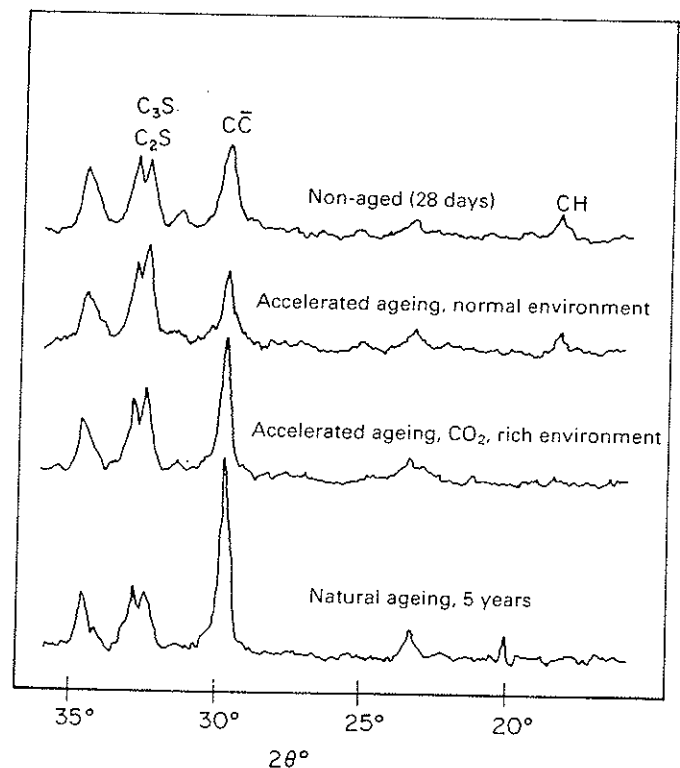
Figure 1 XRD patterns of cellulose-cement composites before and after ageing

Typical XRD patterns are presented in Figure 1, for the unaged composite and for specimens after different ageing treatments. The TG curves showed a distinct weight loss in the temperature range typical to CH and CC and the contents of these two components could be calculated. However, cellulose decomposes at the same temperature range of the CH, and adjustment for that had to be made in the calculation of the CH content. This was done by taking into account the content of the cellulose and its weight loss in this temperature range. The latter value was determined by running a TG test with fibres only. The calculated values of CH* and CC contents are provided in Table 1. The values are presented as percent of weight of the original cement, and for that purpose the loss on ignition value was used.

The XRD patterns and TG results indicate similar trends of relatively low CH values and a considerable amount of CC. In well hydrated cement, the CH content in the absence of carbonation should be about 20%, whereas in this case the values were much lower. These trends suggest considered tendency for carbonation, even in the composites which were not exposed to conditions which do not promote excessive carbonation. The marked increase in CC content could be particularly noticed in the accelerated ageing in a CO₂ environment and in a natural environment, where the CC content was more than twice as much as that in the unaged composite or the composite accelerated aged in a normal

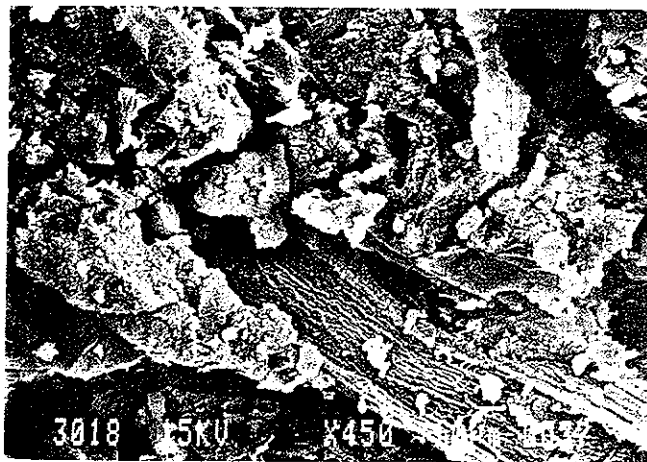
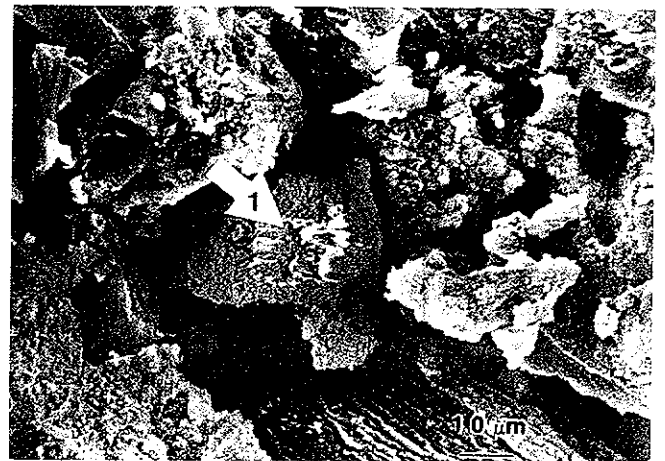
Figure 2 (a) Typical pulled out fibre in an unaged composite; (b) The open matrix at the root of the fibre in (a). The C/S ratio in point 1 is 1.65

Unaged composites The dominant mode of failure was fibre pull-out (Figure 2a), and the matrix around the fibre was relatively porous (Figure 2b). The composition of the hydration products in these zones was typically that of CSH, even when analysing the more dense microstructure (Figure 2b – C/S ratio of 1.65 in point 1). When observing the microstructural characteristics along the fibres, large gaps and cracks in the matrix adjacent to the fibre surface could be frequently seen (Figure 3a, 4a), and fibre matrix debonding was evident in

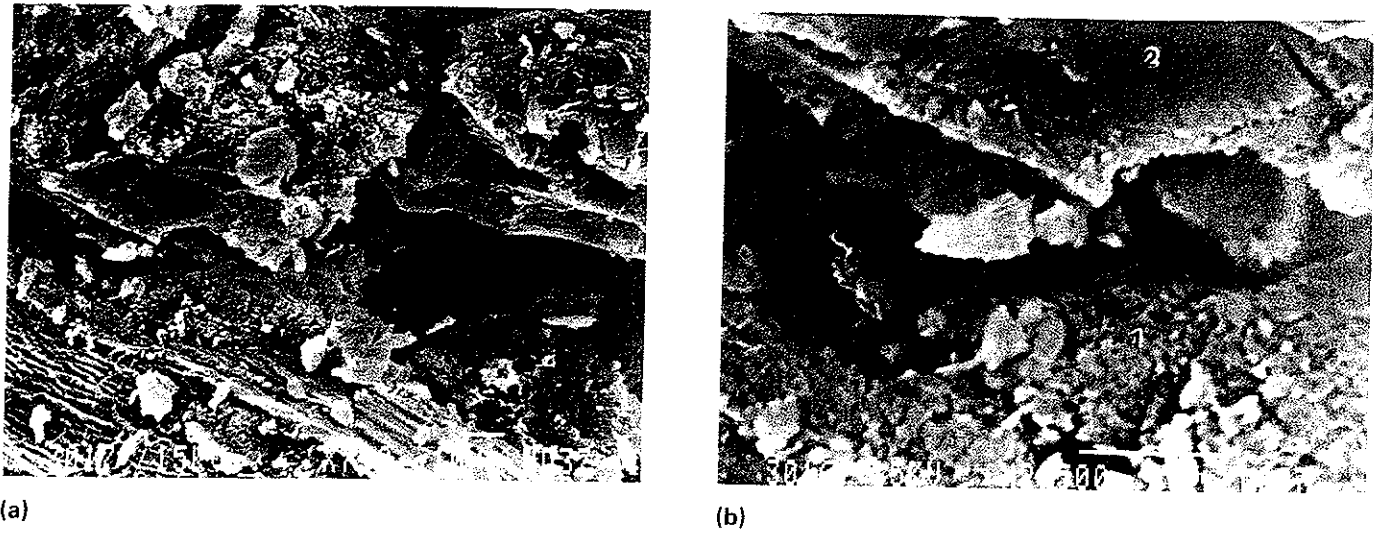
Figure 4 (a) Open and porous matrix along a fibre in an unaged composite; (b) Higher magnification along (a) showing porous and dense hydration product. The C/S ratios of points 1 and 2 are 2.08 and 3.51, respectively

many locations. Although the hydration products were usually non-crystalline in nature, with C/S ratio less than 2 (Figure 2, Figure 4b), some crystalline lamellar structure typical to CH could sometimes be seen (Figures 3b, 4b). However, the C/S ratio in such zones was not extremely high (2 to 4), suggesting either impure CH or more likely a mixture of CH crystals and CSH. In such zones, the microstructure of the products engulfing the fibres was dense, but even here debonding and matrix cracking could be seen.

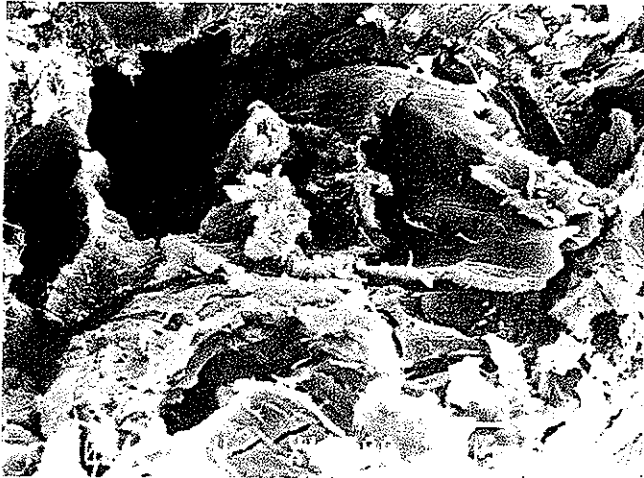
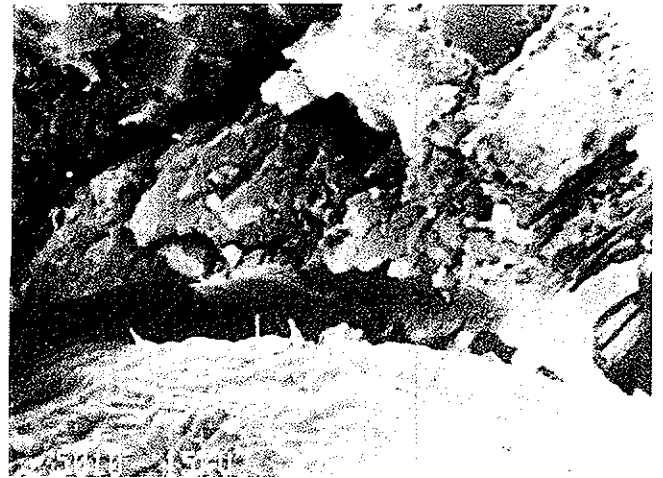
Figure 6 (a) A broken fibre in a composite after accelerated ageing in a normal environment; (b) Higher magnification of the upper part of the interface in (a). The C/S ratio of this zone is 4.87

The fractured surface observed invariably broken fibres with their hollow nature clearly shown in Figure 6a. In some cases, the fibres seemed to be breaking in flexure (Figure 7). In most cases the matrix around the fibres was quite dense, as seen at higher magnifications in Figures 6b, 7b. The C/S ratio in such

zones was usually less than 2, which is in the range typical to CSH. Higher C/S ratios, like 4.87 in Figure 6b were less frequent.

It was typical to observe debonding between the cellulose fibre and the matrix around it. Separations of 1 µm or greater could be measured between the fibre and matrix (Figures 6, 7).

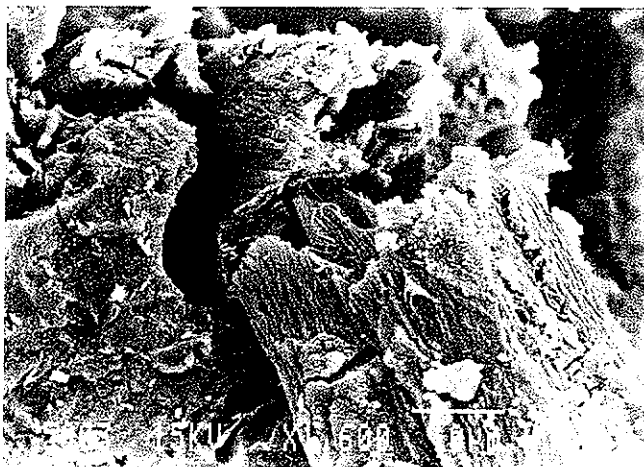
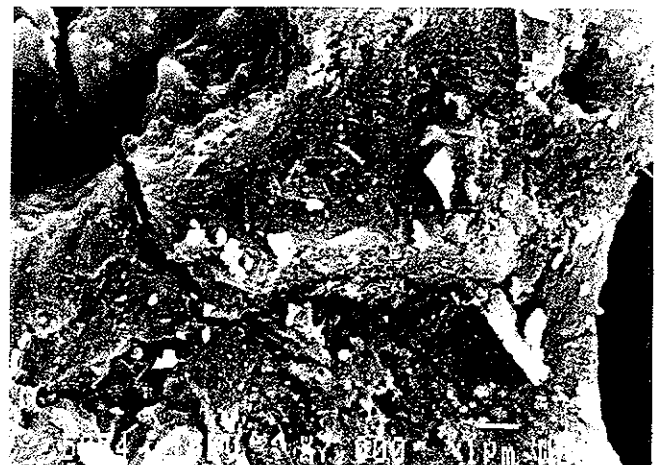
Figure 7 (a) A fibre broken in flexure in a composite after accelerated ageing in a normal environment; (b) Higher magnification of the dense matrix around the fibre in (a). The C/S ratio of this zone is 1.61

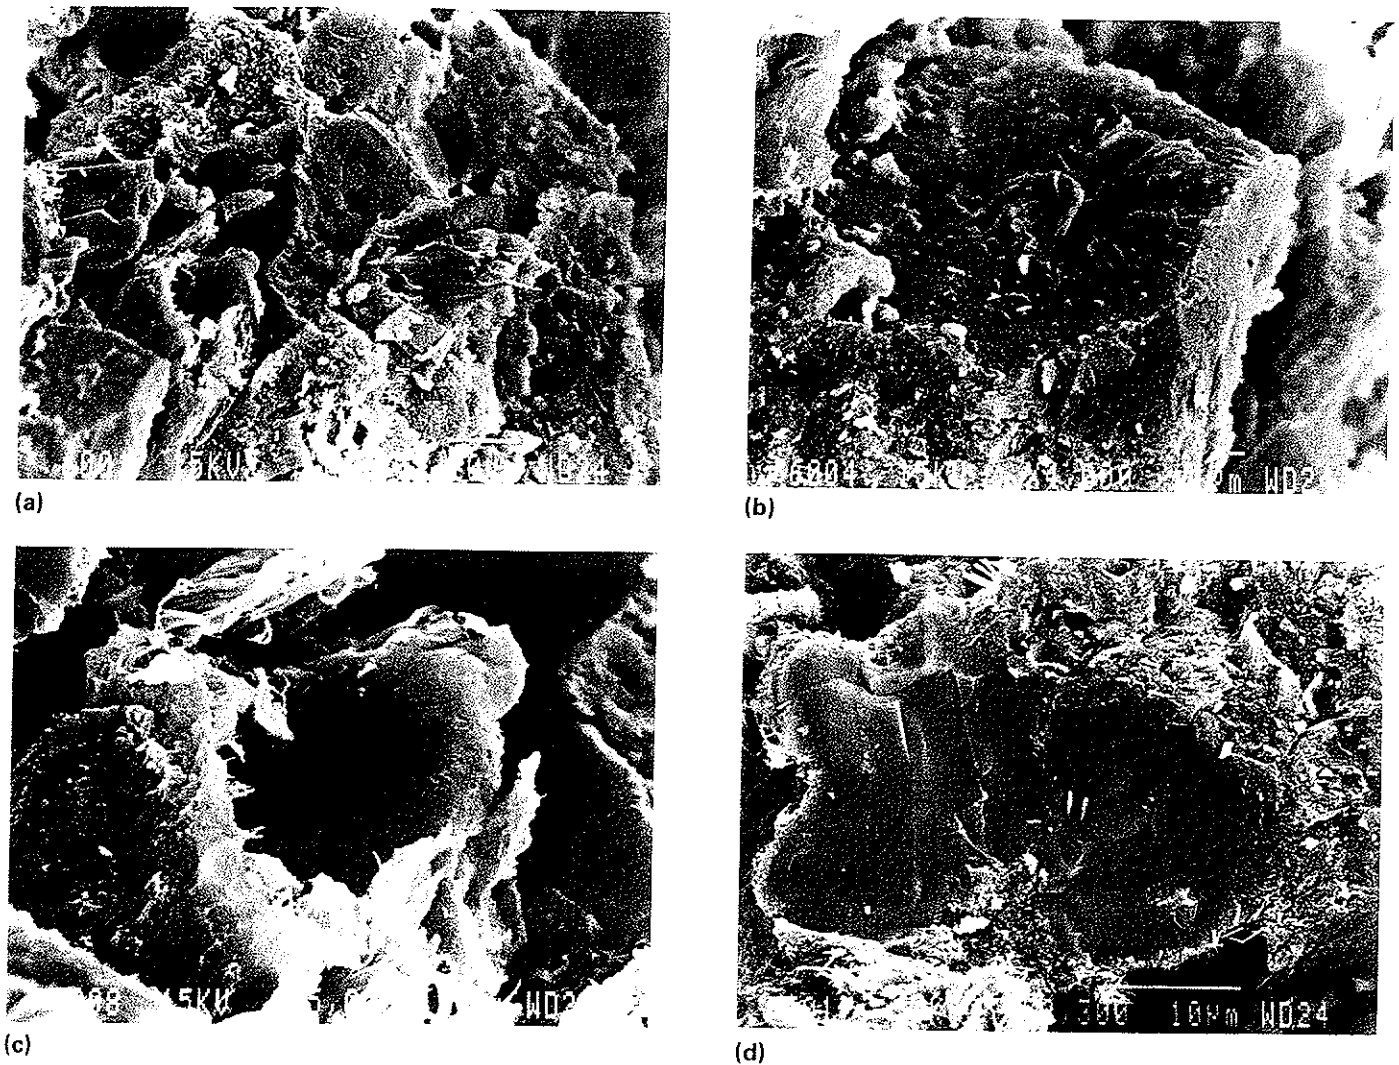
Figure 8 (a) Brittle fracture in a composite after accelerated ageing in a CO₂ rich environment; (b) Higher magnification of one of the fibres in (a) showing the circular morphology filled with dense, massive material ('brittle petrified'). The C/S ratio of the centre is 2.0; (c) Higher magnification of one of the fibres in (a), showing the circular hollow fibre ('brittle cellular'); (d) The dense matrix around a petrified fibre

The mode of fracture of these specimens was brittle, with most of the fibres being broken at the fractured plane (Figure 8a). Very frequently, the circular cross section of the broken fibre was filled up with what seemed to be dense hydration products (Figure 8b). The C/S ratio in these dense zones was 2 or less. It should be noted that in these 'filled' fibres no perimeter debonding could be seen. This microstructure will be referred to as 'brittle petrified'.

In fewer instances the fractured fibres were hollow inside, revealing the usual structure of the cellulose fibre (Figure 8c). In a few cases one could see the holes left in the matrix around fibres which probably pulled out (Figure 8d). The matrix was usually dense, similar to that observed around the zones where the fibres were still present on the fractured surface.

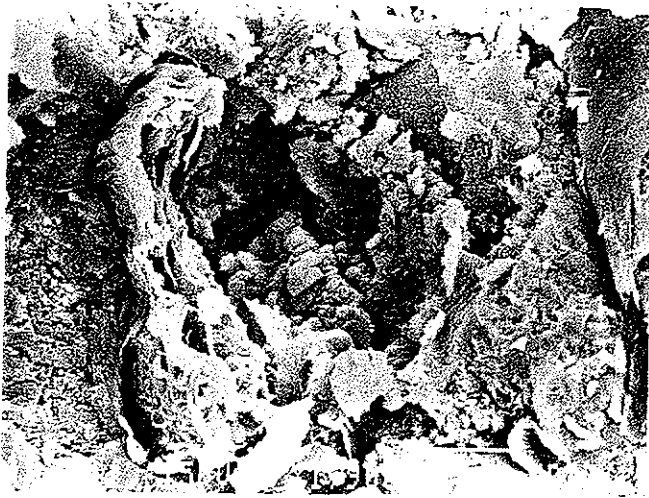
Figure 9 Brittle failure of a partially 'petrified' fibre in a composite after accelerated ageing in a CO₂ rich environment

In one case (Figure 9), the perimeter of a cellulose fibre could be seen slightly below its broken surface, and within its perimeter, there appeared to be dense and porous hydration products filling the circular space. This was a rare observation, and cannot be considered typical. Observations of this kind may suggest that the morphology defined previously as petrified fibres, was originally a cellulose fibre which became filled with reaction products. In order to verify this hypothesis, the specimens were treated with hydrochloric acid, which can dissolve the reaction products, without damaging the cellulose fibres. Observations after brief etching are

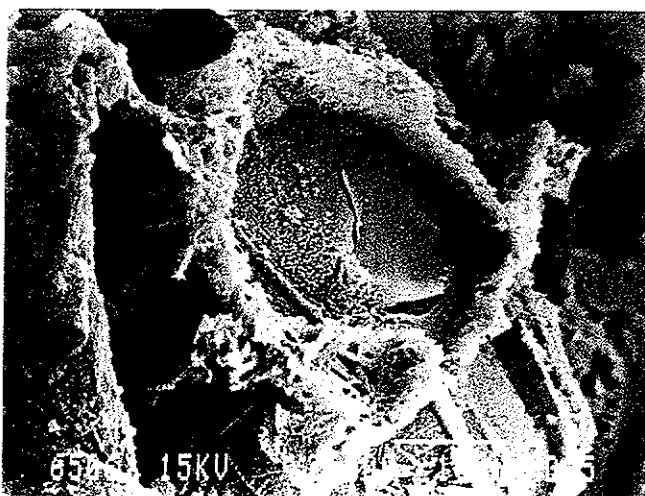
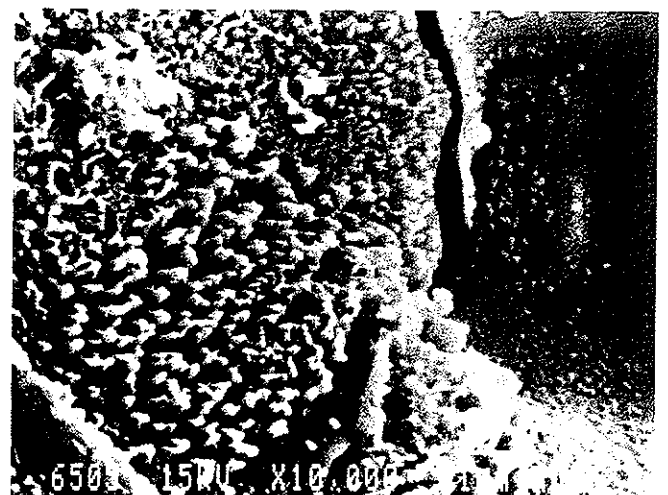
Figure 10 Fibres revealed after brief etching of a composite after accelerated ageing in a CO₂ rich environment; (a) General view of a fibre, showing the fibre with dense material deposited in the core surrounded by the fibre wall; (b) Higher magnification of the centre of (a), showing the etched nature of the material. The C/S ratio at the centre is 1.37

Brief etching clearly revealed the typical structure of the cellulose fibres. In some cases the core of the fibre was vacant, but often the perimeter of the fibre wall could be seen, and within it the etched hydrated material which dissolved only partly on the surface (Figure 10). Higher magnification of the centre of such zones clearly revealed the etched nature of the surface (Figure 10b). The C/S ratios in such zones were about 1.30 which is indicative of the composition expected in slightly etched CSH. These micrographs clearly indicate that the petrified morphology, which was so typical to the accelerated ageing in CO₂ rich environment, was indeed

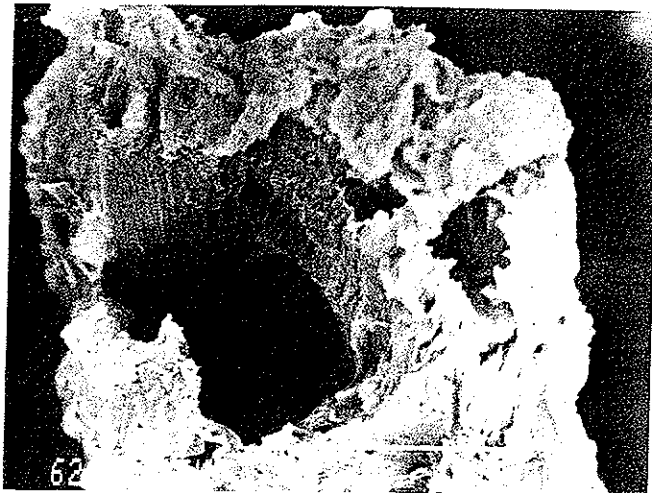
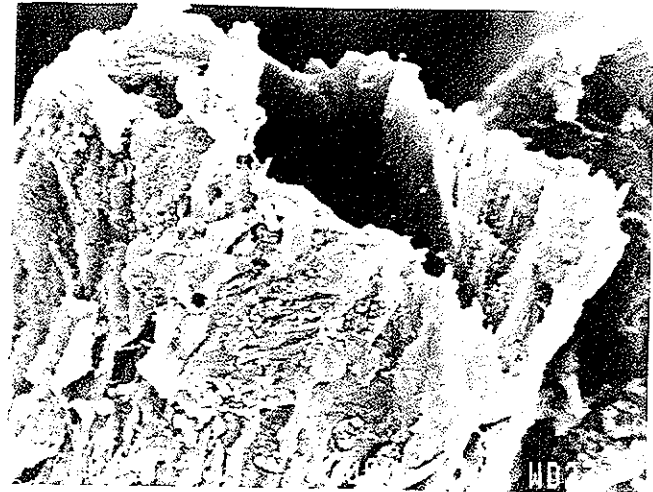
Figure 11 (a) Fibre revealed after more intense etching of a composite after accelerated ageing in a CO₂ rich environment; (b) The C/S ratio of the cell wall in (b) is 0.20

The more extensive etching removed completely the reaction products within the cellulose fibres and around them. The frequent observation of the circular cross-section of the cellulose, is a manifestation of the brittle fracture of the fibre. The hollow and fibrillar characteristics were clearly seen in etched specimens (Figure 11), but were absent in the unetched specimens, where the fibres were impregnated with reaction products leading to the formation of the petrified morphology. EDXA of the extensively etched fibre walls gave a weak signal of Ca and Si with the C/S ratio being about 0.20. The fact that such a signal could be obtained may indicate that the walls of the cellulose fibre contained some calcium silicates and the signal observed was that of the remnants of such etched material. Acid treatment of the calcium silicate is expected to dissolve most of them and leave behind a residue of silica gel, which may account for the low C/S ratio observed.

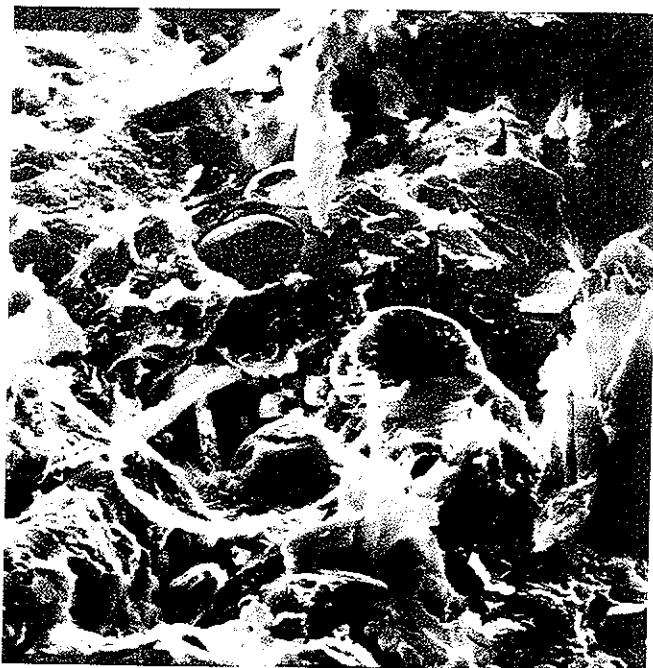
Figure 12 Brittle fracture in a composite after ageing for 5 years in natural weathering

The typical mode of fracture was brittle in nature, with the fibres breaking at the fractured plane, or being pulled out slightly before being fractured (Figure 12). The hollow nature of the fibres was usually not present, and as in the case of accelerated aged specimens in a CO₂ environment, the circular cross-section of the fibre was characterised by a dense microstructure (Figure 13). Only in a few instances could the remnants of the hollow nature of the fibre be seen at the broken surface. Also, only seldom was a fibre pulled out of the matrix during fracture. Regardless of the mode of fracture, the matrix around the cellulose fibres was quite dense (Figure 14a). Only in a few instances could one see some more porous matrix around the fibres, as demonstrated, for example,

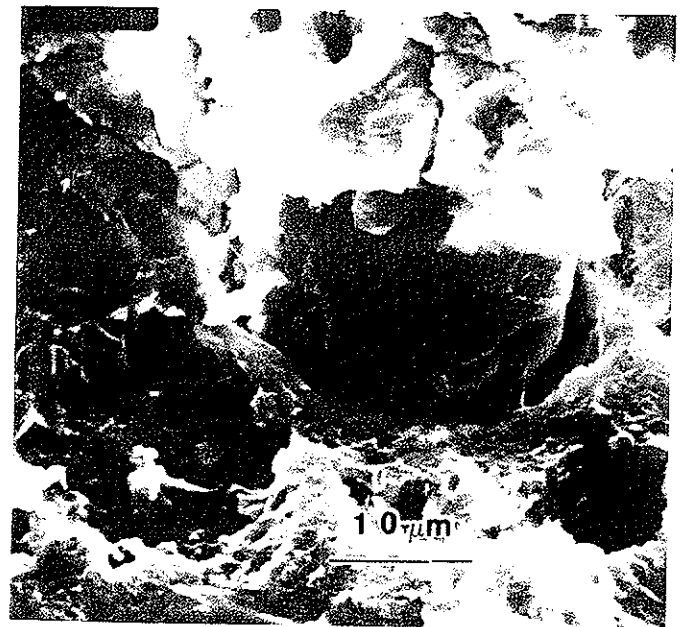
Figure 13 Brittle petrified fibre in a composite after ageing for 5 years in natural weathering (left fibre in the micrograph)

It should be noted that in the places where the fibres were broken in a brittle manner, revealing a dense,

petrified, microstructure in the fibre cross-section (Figure 13), no bond separation at the perimeter of the fibre could be seen.

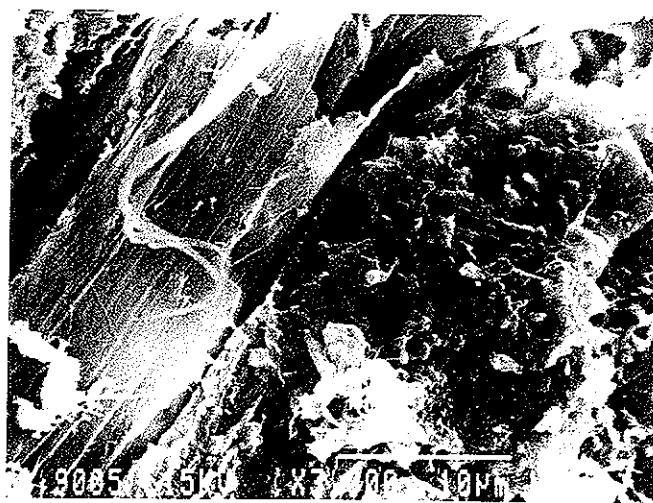
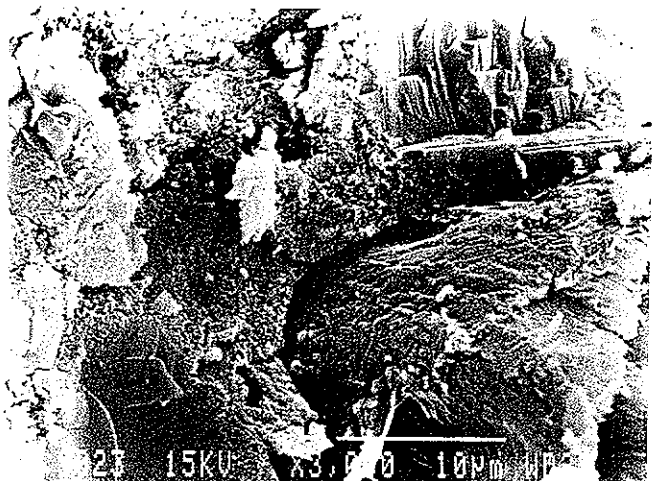
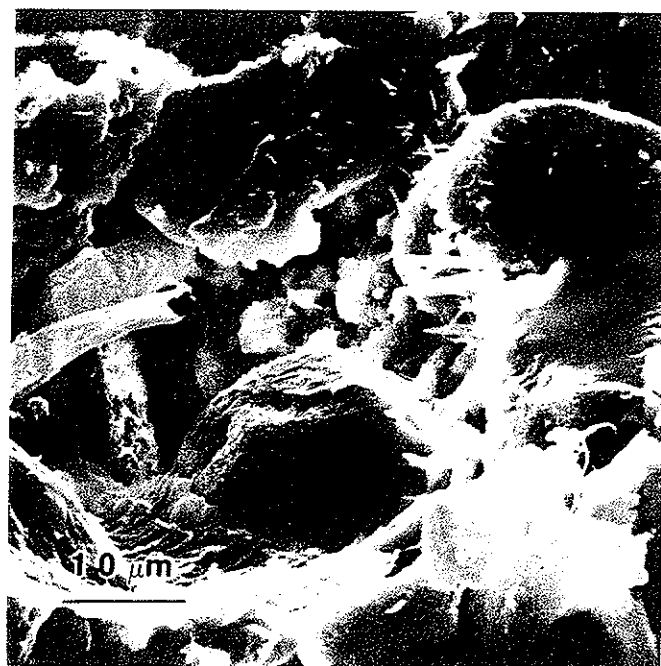
Figure 14 The matrix around the fibre in a composite after ageing for 5 years in natural weathering; (a) Dense matrix; (b) Porous matrix; (c) Dense matrix, with some crystalline material at the right side with C/S ratios of 10.5

in Figure 14b. Usually, the C/S ratio of the matrix surrounding the fibres was about 2 or less. Only in a few points was the C/S ratio greater than 3 and, even then, no crystalline morphology was evident. On rare occasions one could see the presence of dense crystalline zones, typical to CH, where the C/S ratio was higher than 7 (Figure 14c).
